Manhole Inspection Summary

Manhole # S29A__094MH

Insp Date: **4/28/09 3:41 PM**

Location Address: **1001 MYRTLE AVE**

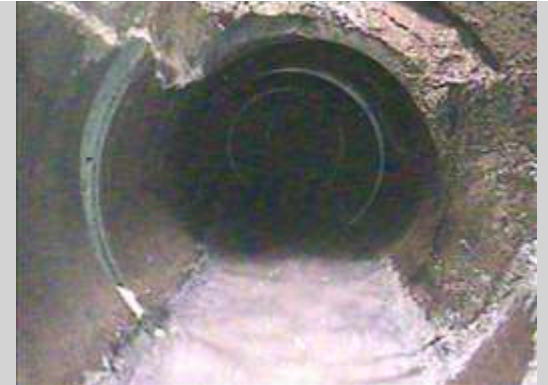
12 O'Clock Outflow

21 in. Circular Gravity Sewer
Pipe Out @ 12 O'Clock

Pipe Material: **Clay** ☐ Pipe Lined

Invert Depth: **11.40** (ft.) Flow Characteristics: **Fast**

Deposits: ☒ None ☐ Mud ☐ Sludge ☐ Debris ☐ Grease

Infiltration: **None** Pipe Seal Cond: **Sound**

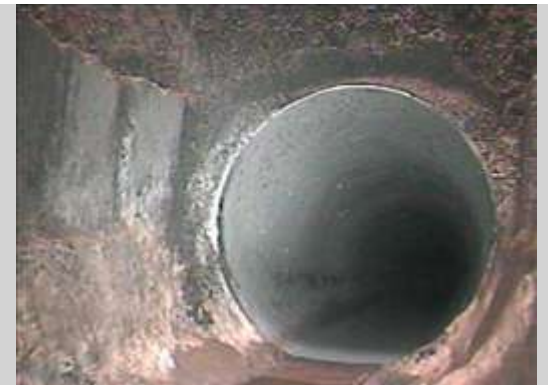
6 O'Clock Inflow

21 in. Circular Gravity Sewer
Pipe In @ 6 O'Clock

Pipe Material: **Clay** ☐ Pipe Lined

Invert Depth: **11.28** (ft.) Flow Characteristics: **Fast**

Deposits: ☒ None ☐ Mud ☐ Sludge ☐ Debris ☐ Grease

Infiltration: **None** Pipe Seal Cond: **Sound**

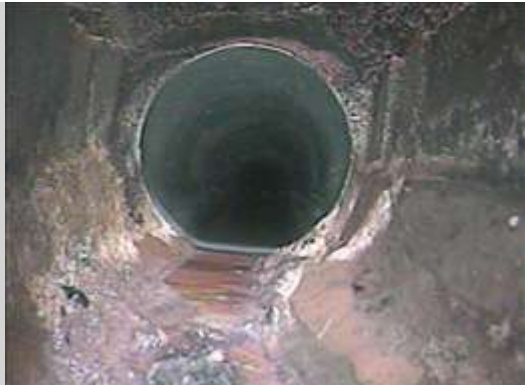
9 O'Clock Inflow

8 in. Circular Gravity Sewer

Pipe In @ 9 O'Clock

Pipe Material: **PVC** ☐ Pipe Lined

Invert Depth: **10.61** (ft.) Flow Characteristics: **Slow**

Deposits: ☒ None ☐ Mud ☐ Sludge ☐ Debris ☐ Grease

Infiltration: **None** Pipe Seal Cond: **Sound**
